# Jetting Under D.C.

EQUIPMENT MODIFICATIONS ENABLE A CONTRACTOR TO CLEAN A GRAVITY LINE 40 FEET BELOW A WASTEWATER TREATMENT PLANT IN WASHINGTON, D.C.

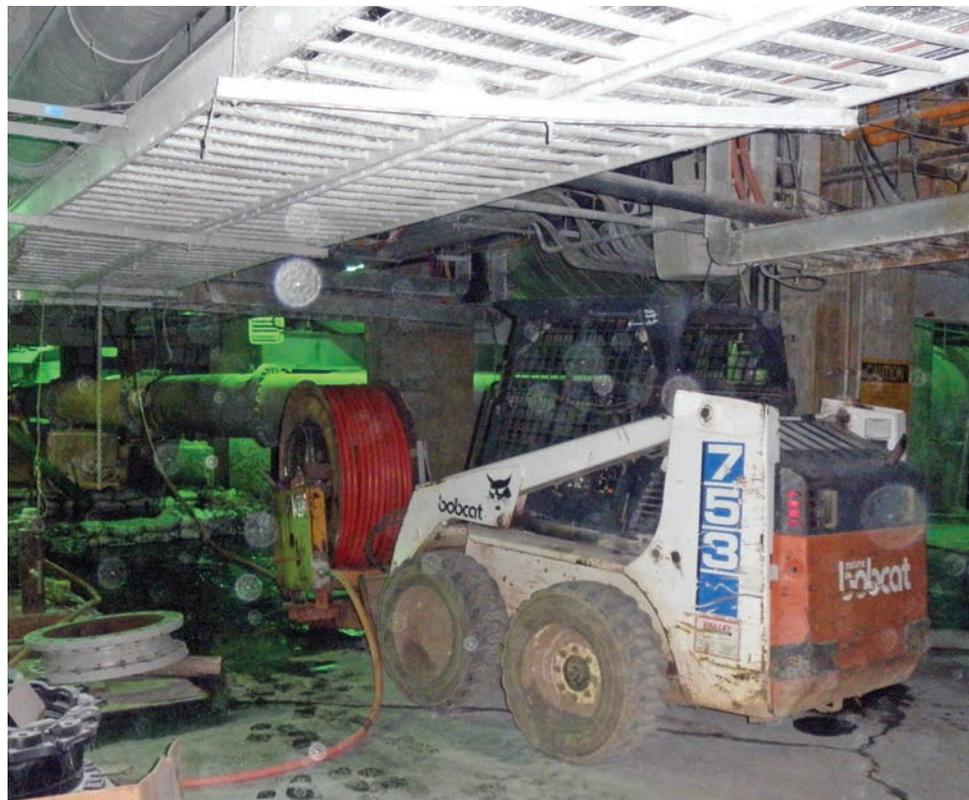
To clean the pipe 8 feet overhead, Tom Buchwald bolted the hose reel and controls from a Vac-Con X-Cavator to the front of a 753 Bobcat loader. The 2-inch water supply hose is attached to the left, while the 2-inch jetting hose snakes forward and upward. (Courtesy of Quality Pipe Cleaning Co.)

Buchwald's answer involved bolting the hose reel and controls from a Vac-Con X-Cavator to the front of a 753 Bobcat loader and staging two hydro-excavators near a service stairwell. Despite unforeseen obstacles, eight employees working 10-hour shifts cleaned the line in 10 days.

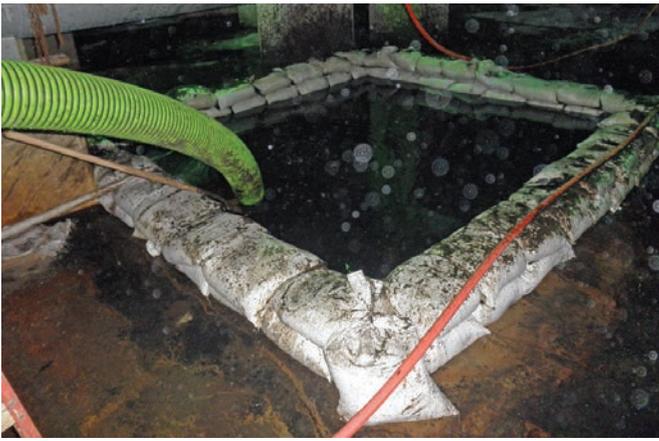
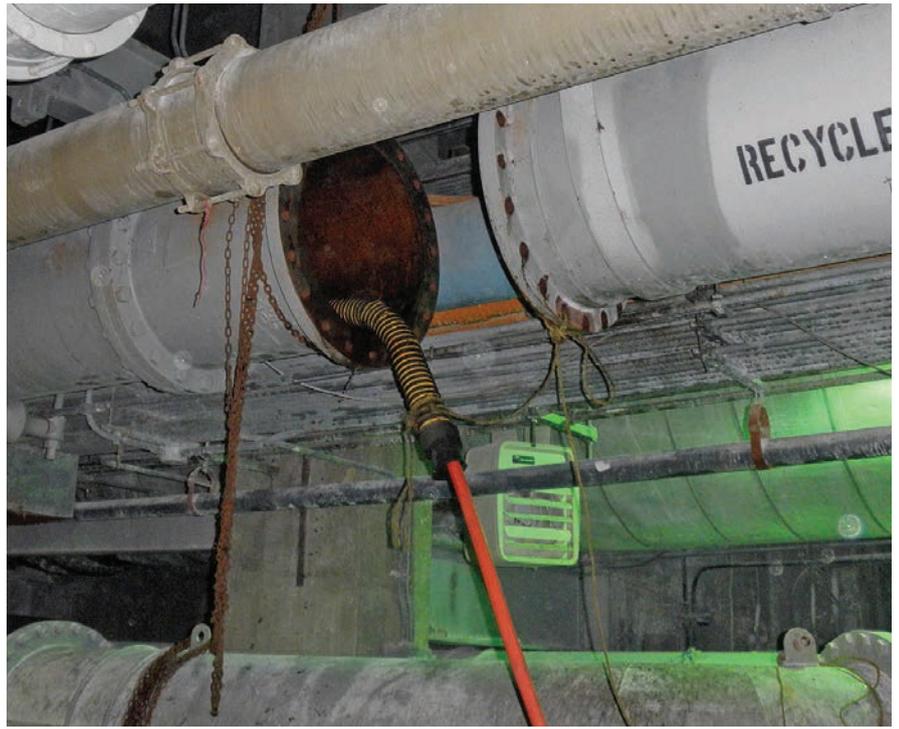
ABOVE: Built from two rows of sandbags, the 15- by 15-foot capture pit was 18 inches high and leaked badly. The camera captured flying spray. RIGHT: A rope tied through the bolt holes in the pipe secures the jetter hose, preventing it from falling out. Plant operators used the hanging chains to lower the valve they cut out of the line.

The crew hauled 200 feet of 6-inch flexible hose down six flights of stairs, then brought 60 feet of 8-inch hose for vacuuming and the 1/2-inch hose supplying water to the jetter. To access the pipe eight feet overhead, plant operators had removed valves at two locations. Swerda’s crew tied a rope through the bolt holes in the pipe to the rear to secure the jetter hose and prevent it from falling out.

To capture the debris, the men built a 15- by 15-foot pit 18 inches high from two rows of sandbags.

The pit leaked badly. Workers corralled the overflow and pushed it back to the hose with squeegees. When they thought the section was clean, Swerda televised the line with an OZ II camera on a wheeled Pipe Ranger from CUES.

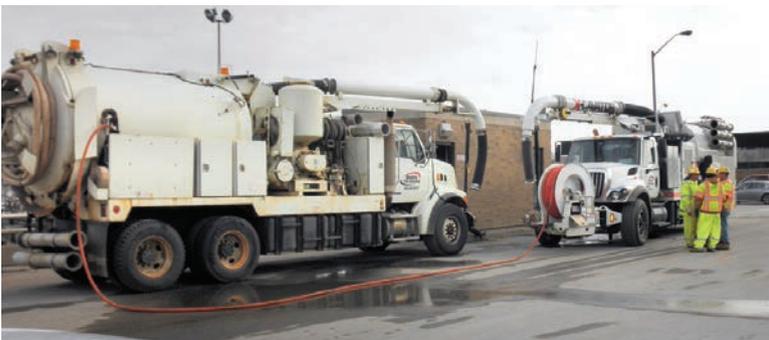
The pump house, the last building in the background, is 800 feet from where the trucks are mobilized.
